RE: 2024 Mazda CX-3 Red. — vehicle

2024 Mazda CX-3 Red.

Diagnosis | **Scheduled 20,000 km / Annual Service** | Auto Admin · 25/03/2026 02:01
Customer Reported Symptoms

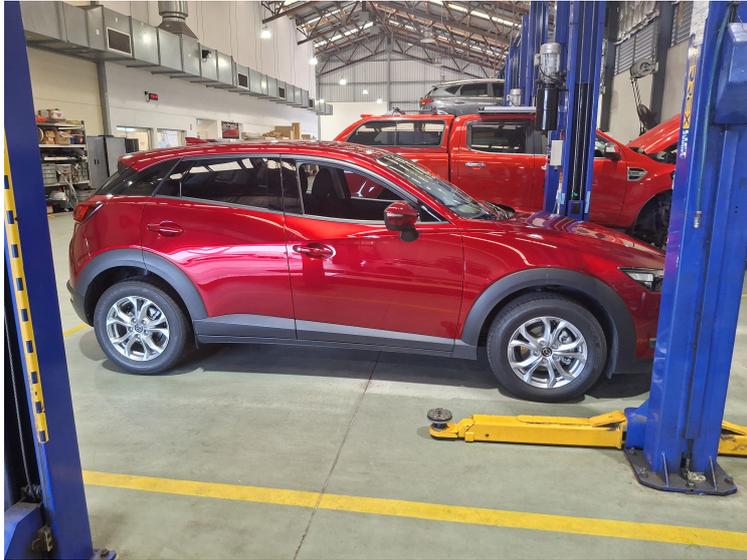
CX3 RHS

Diagnosis | Noise from RHS front | Auto Admin · 30/03/2026 02:49

This was a stone in the wheel assembly
